RESEARCH ARTICLE

LONG-TERM RESULTS OF RECHANGES UNCONVENTIONAL PROSTHETIC PARTS SERIAL TO CONSERVE PELVIC LIMB BECAUSE OF OSTEOSARCOMA

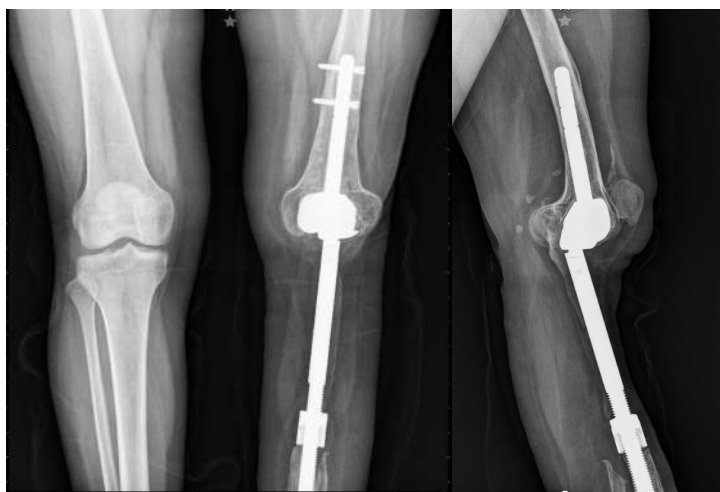
Fig. 1. Radiography anteroposterior and lateral left knee with tumor prosthesis fatigue seen in proximal tibial component. 2009

Presence of radiopaque line ("clear sign"), and the "sign of the metal line," a thin edge higher linear density in the region of the suprapatellar pouch.

The patient only accept surgery by local symptoms of pain and increase in limiting knee flexion. Metallosis was suspected radiographically by their typical appearance: "sign cloud" that are periprosthetic amorphous densities of the soft tissue, the "sign of the metal line," a thin edge higher linear density in the region of the suprapatellar pouch and the "sign bubble", a curvilinear radiodensity delimiting the articulación¹³. revision surgery revealed massive infiltration of muscle and soft tissue metals (Kinds *et al.*, 2012; Ho *et al.*, 2018). After 3 months of assisted rehabilitation, the patient returned to their activities, start of the march with support walker. Currently the patient is uncomplicated. General and imaging studies were normal and no evidence of tumor or infectious reactivation.

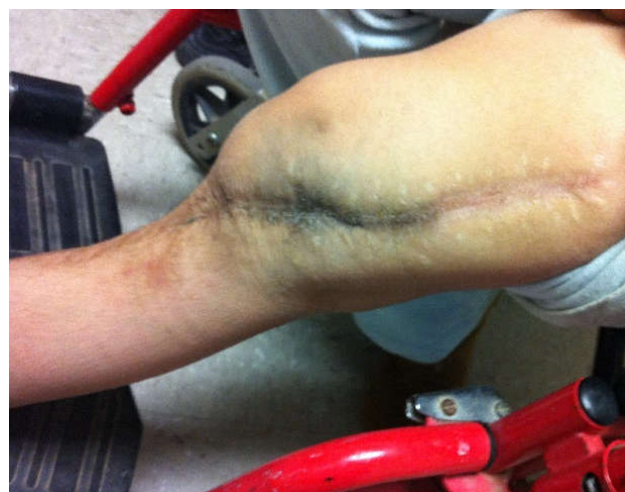
Fig.2. image shown in discoloration (discoloration) in the lateral skin left knee.

Unconventional prosthetic reconstruction cementless with locking bolts after tumor resection of the distal femur and proximal tibia described successfully in 75% of patients. Reviewing tumor knee prosthesis due to breakage tibial or femoral component is indicated immediately way (Langton *et al.*, 2011). The most common reason implant failure is aseptic loosening followed by the failure of the implant and infección⁵. Metallosis represents a rare complication (Common) after failure of secondary tumor prosthesis to break components. Since the metallosis consists of the deposition of metallic debris in the periprosthetic soft tissue affecting capsule or joint cavity, and extraarticulares tissues (Jayasekera *et al.*, 2015). Deposition of waste from the prosthesis to the periarticular soft tissue can cause pain and systemic effects, but also can be asymptomatic, manifesting only with skin pigmentation. In case of failure of the prosthesis, an early review is recommended. In this particular case the patient decides to wait for surgery for a year and a year later pregnancy, so she received a late review which resulted in a massive deposition of metals in soft tissues. The patient had a large area of skin metallosis characterized by skin pigmentation lining the joint space of the affected limb.

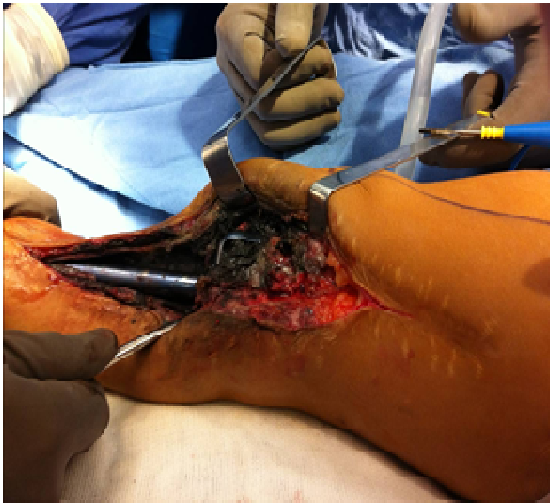
Fig. 3. In the surgical approach He confirmed the presence of a massive metalosis soft tissue of the distal femur and proximal tibia. Noting the little difference of soft tissue by infiltration metal.

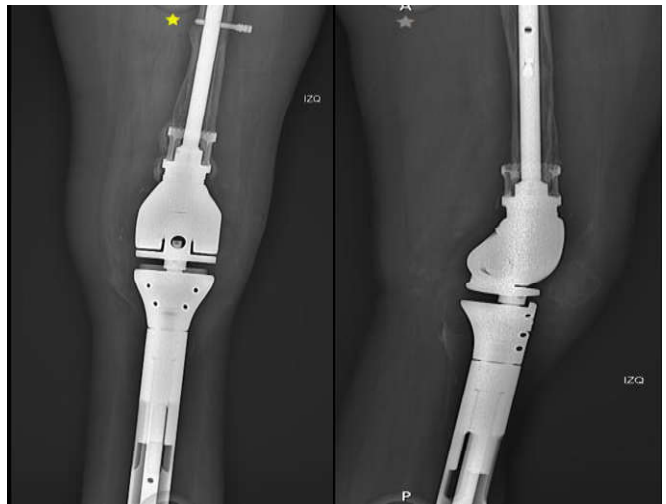
Fig. 4. anteroposterior and lateral left foot Radiography, unconventional new tumor prosthesis is observed. Note the soft tissue suitable radiolucides knee level. Definitiva

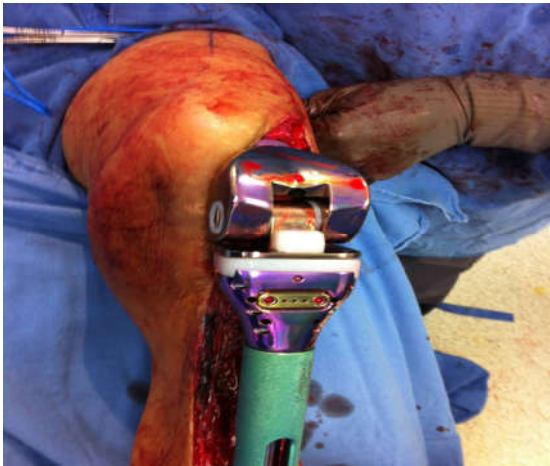
Fig.5. Clinical flexion tests to determine the orientation of the components.

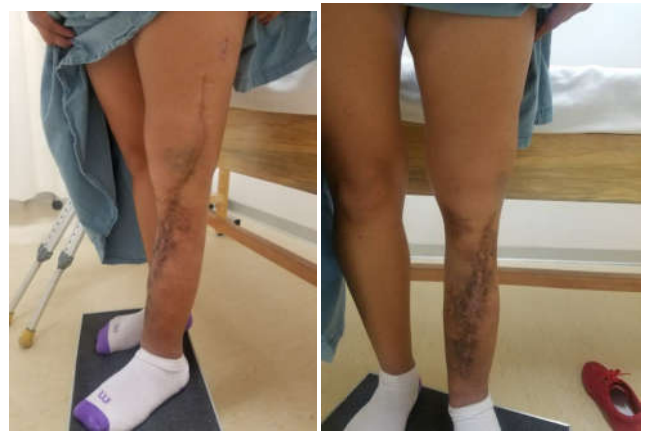
Fig. 6. Observe adequate healing and no change in skin color.

began the second postoperative day. The patient was discharged from hospital without complications after 10 days. At the last follow, in June 2017 the patient had joint knee stable and pain, with proper healing (Fig. 6). He continued rehabilitation, gait assessment with support walker, knee flexion 60 °. scintigraphy was performed with labeled leukocytes demonstrating absence of infection. Our patient was informed that data obtained from their case would be submitted for publication and authorized with a signed written informed consent.
